KEMP LAKE DAM

CRAWFORD COUNTY, MISSOURI

MO 30035

PHASE 1 INSPECTION REPORT

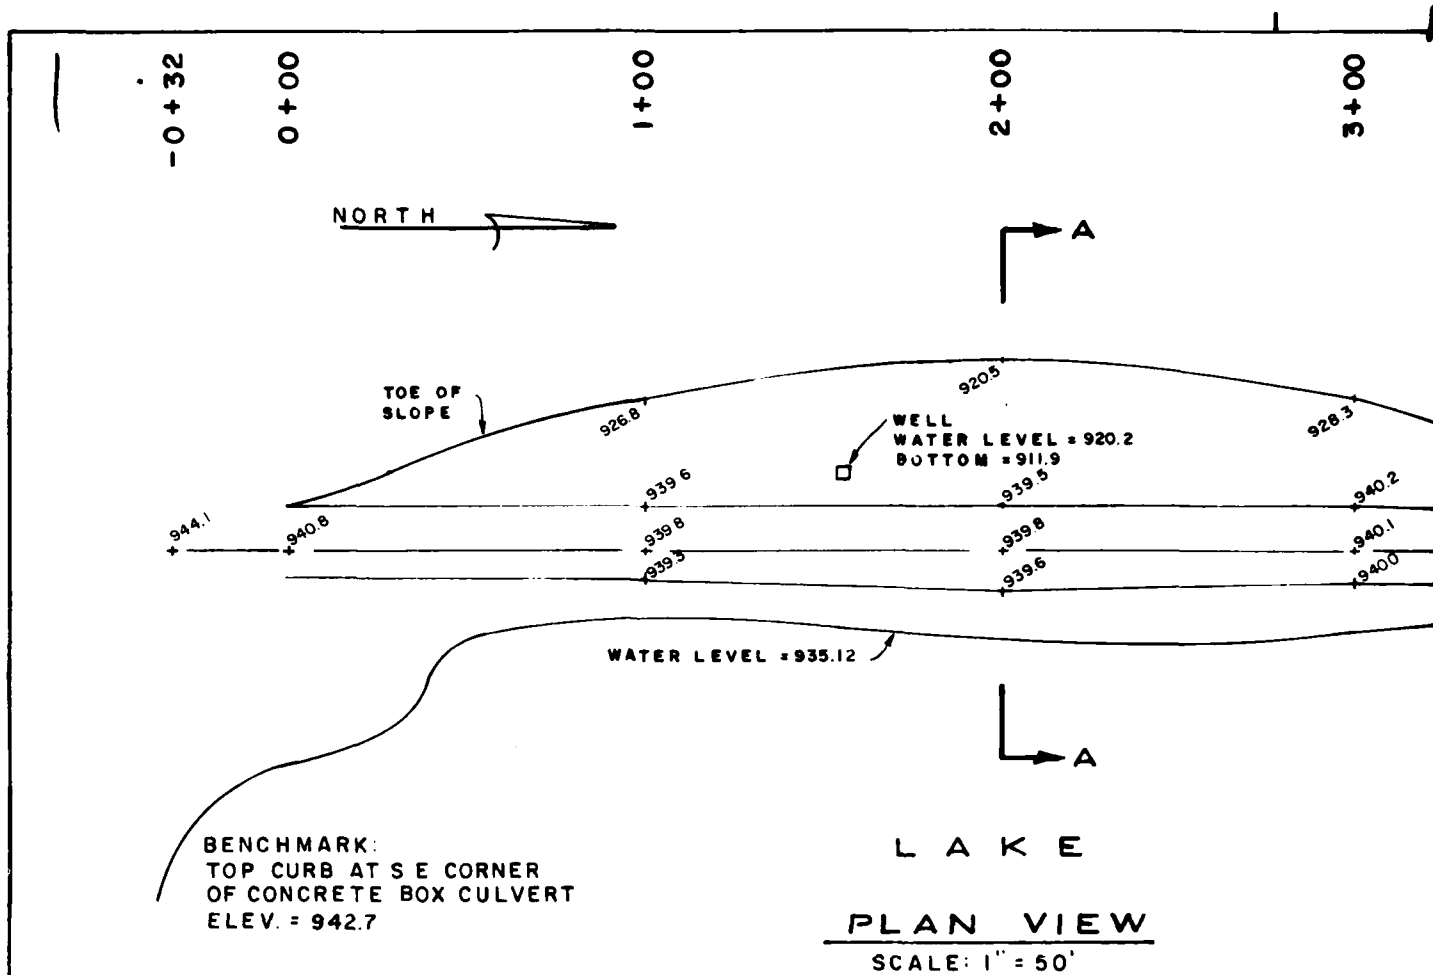
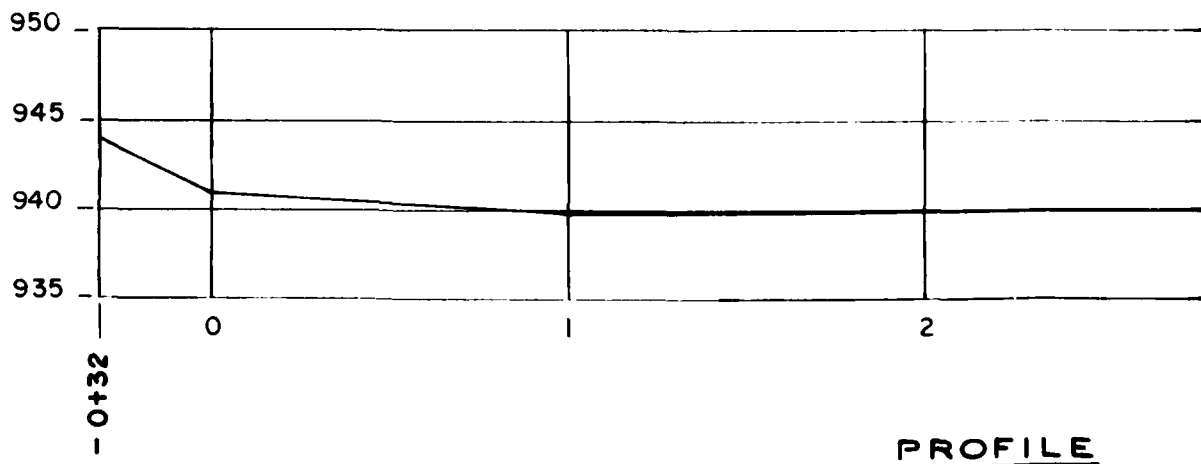
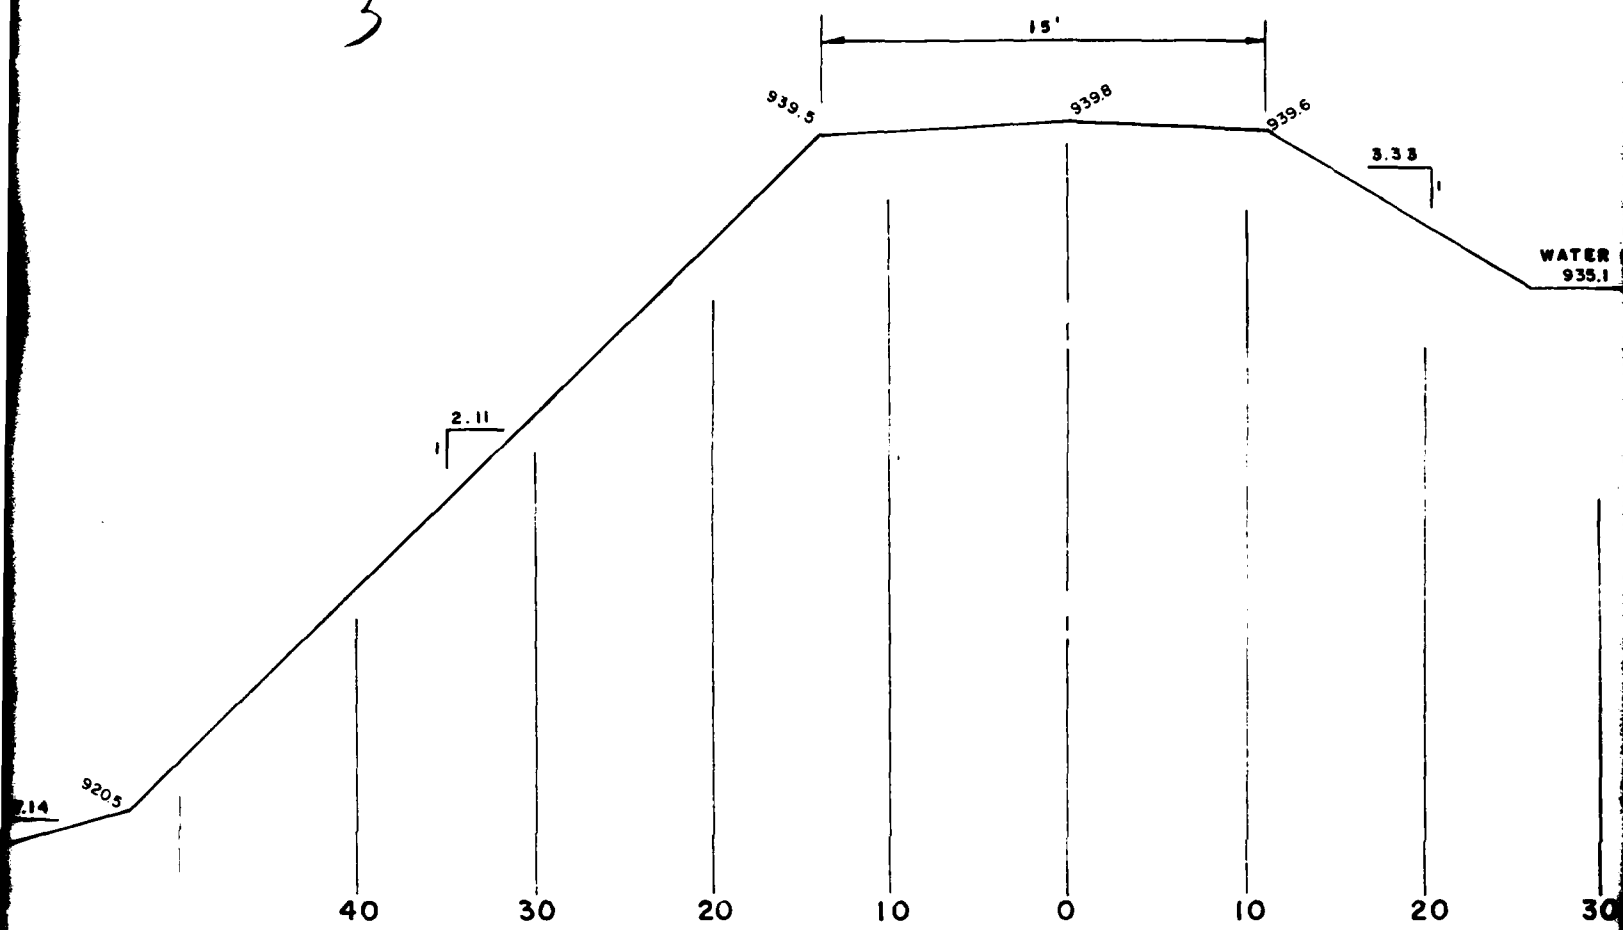
Kemp Lake Dam is an earth fill structure approximately 22.1 ft high and 386 ft long at the crest. The appurtenant works consist of a rock cut spillway located at the north end of the dam, a concrete box culvert bridge over the spillway and a hand-laid flagstone well located near the center of the dam just downstream of the crest. Sheet 3 of Appendix A shows a plan, profile and typical section of the embankment.
